**July 10, 2020**

**Re: Tree Survey for the Village At Ruddy Creek Project – Oroville, Butte County, California.**

As requested, Gallaway Enterprises conducted a Tree Survey for the Village at Ruddy Creek Project (Project) on March 26 and April 1, 2020. Please find enclosed a summary of the results of the survey conducted.

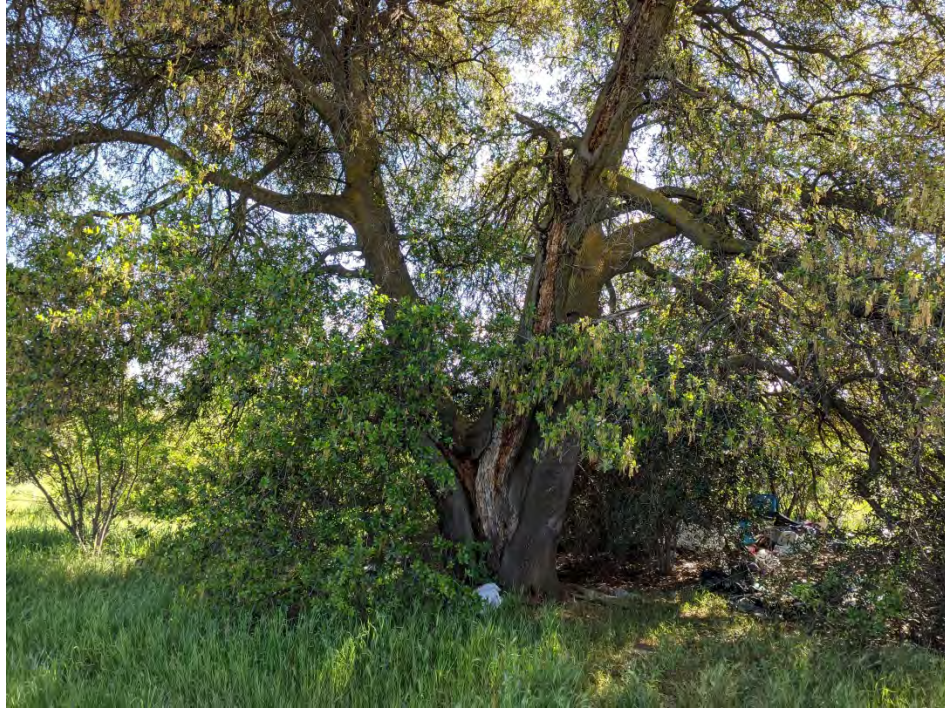
Only two native live oak trees (T011 and T050) were identified as having a single trunk 24 inches or greater in dbh within the Project site (**Attachment A**). A table listing each tree surveyed within the Project site and its assessed health rating is provided in **Attachment A** along with the tree location map. A few pictures of the site are provided as **Attachment B**.

Tree # 11 – large protected/heritage live oak with extensive decay

It is recommended that as many healthy oak trees (trees with a health rating of 3 or greater, **Attachment A**) as feasible be retained within the Project site due to their aesthetics and usefulness to wildlife. In June of 2020 a site visit was conducted by the City of Oroville's Arborist, Wade Atteberry, to assess the two heritage trees on the Project site (T011 and T050). Following this site visit the City's Arborist did not recommend retaining the two heritage trees due to the fact that these large mature trees were in a state of 'heavy decline.'

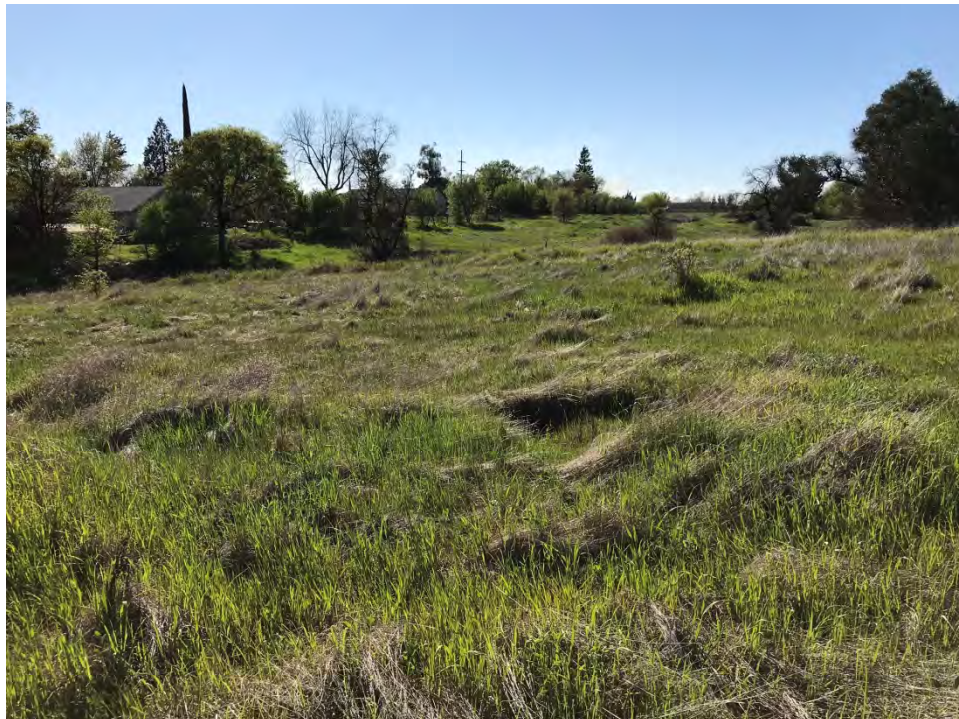
Overview of southern boundary of the site
